Cold Climate Region: Case Study #1 City of Boulder, SmartRegs Ordinance Single Family Detached, 1960's Vintage

Program SmartRegs Ordinance
Location: Boulder, Colorado
Building Type: Single Family Detached
Building Size: 955 ft²
Foundation: Unconditioned Crawlspace
Configuration: 3 bedrooms, 1 bath

Cold Climate Region: Case Study #1 SmartRegs Compliance

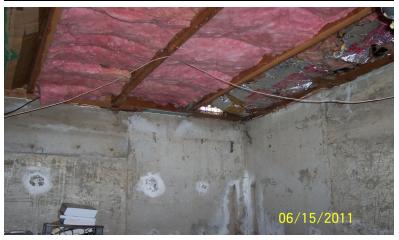
This home receives no credit for the crawlspace ceiling insulation because the majority of the ductwork is located here.

There could be several reasons for this. First, the SmartRegs' prescriptive checklist does not give any credit for insulation in a crawlspace ceiling (R-11 in the ceiling of this crawlspace) if the mechanical equipment and/or any of the ductwork are located in that space.

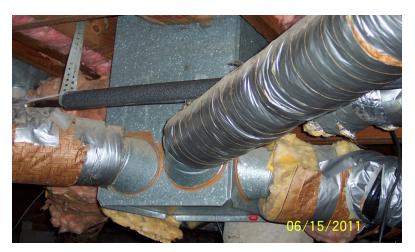
Main supply plenum from down flow furnace with supply branch takeoffs. 99% of the supplies are located in this crawl.

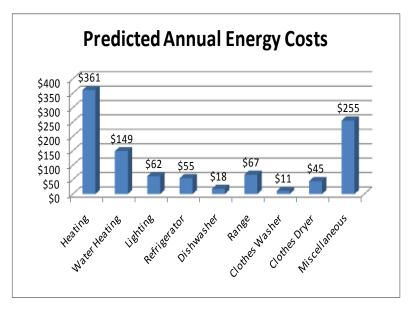
Predicted annual utility bills for this property are displayed in the graph to the right. REM/Rate predicts an overall annual utility bill of \$1022: about $\frac{1}{3}$ (\$361) is attributed to heating.

Predicted Monthly Utility Bills from REM/Rate.
